Analysis of Aquawrap[®] for use in Repairing Pipelines with a Dent / Gouge Defect

Procedure and Evaluation of Cycle Test

Prepared By
Franz Worth, PE

April 19, 2005

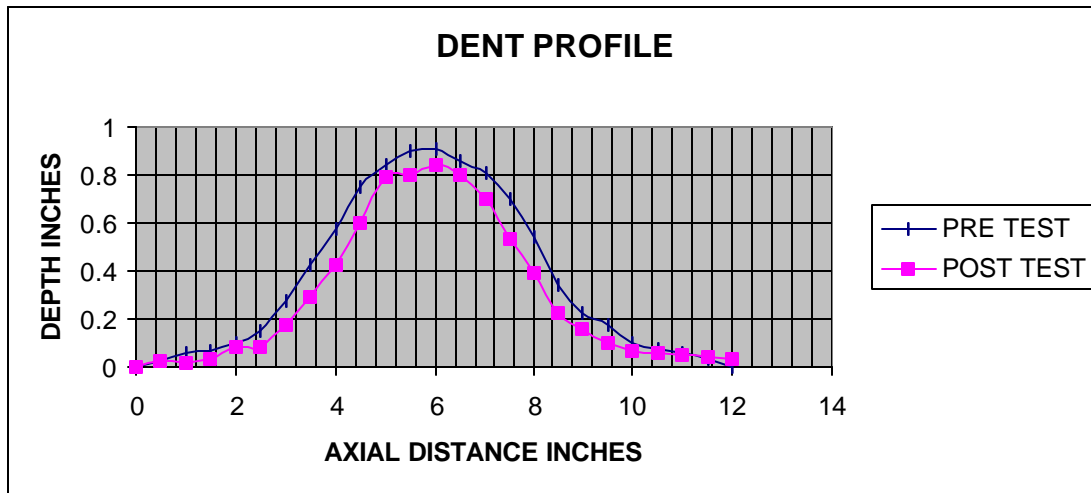
Prior to the repair, the pipe specimen was taken to Authorized Testing and pre-conditioned. The pipe was hydrostatically pressurized and taken from 0 psi to 900 psi within 7 minutes, and then was held at that pressure for another 7 minutes. The pressure was then relieved and the pipe drained of water. Very little re-rounding of the dent was observed. Refer to Fig. 4 for before and after measurements. The pressure of 900 psi was calculated by figuring what the MAOP would be, given the depth of the wall loss within the dented area.

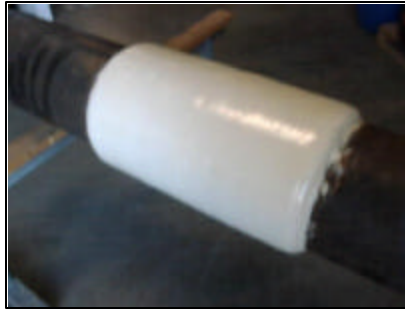
Fig. 8 – Finished repair with 34 layers of Aquawrap® G-05.
